Manhole Inspection Summary

Manhole # S23A__029MH

Insp Date: **7/27/07 7:51 AM**

Location Address: **630 VINCENT-GILMORE**

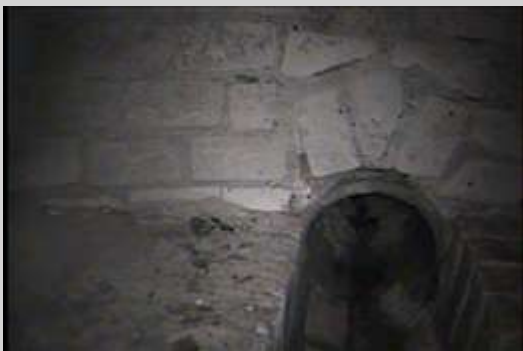
6 O'Clock Inflow

6 in. Circular Gravity Sewer
Pipe In @ 6 O'Clock

Pipe Height: **6** (in.) Rod and Bar (Angled)
Pipe Material: **Clay** ☐ Pipe Lined
Invert Depth: **10.31** (ft.) Flow Characteristics: **Slow**
Deposits: ☒ None ☐ Mud ☐ Sludge ☐ Debris ☐ Grease
Silt Depth: (in.) Deposits Extent:
Infiltration: **None** Pipe Seal Cond: **Sound**
